January 16, 2025

Donald Myers
Tech-Bond
381 South 30th Street
Heath, OH 43056

Test Report on: Salt Spray Testing of 12 steel tubes with various coatings.
MEi Test Report J0687.1, Issue 1

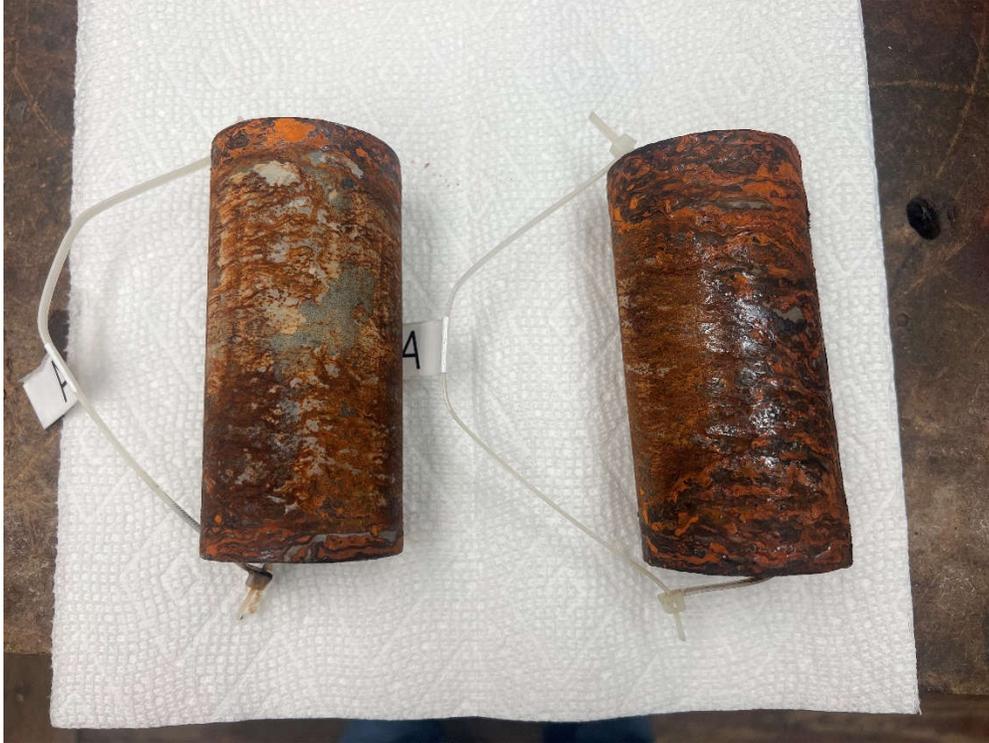
Figure 7: Photographs showing samples A after 100 hours of exposure.

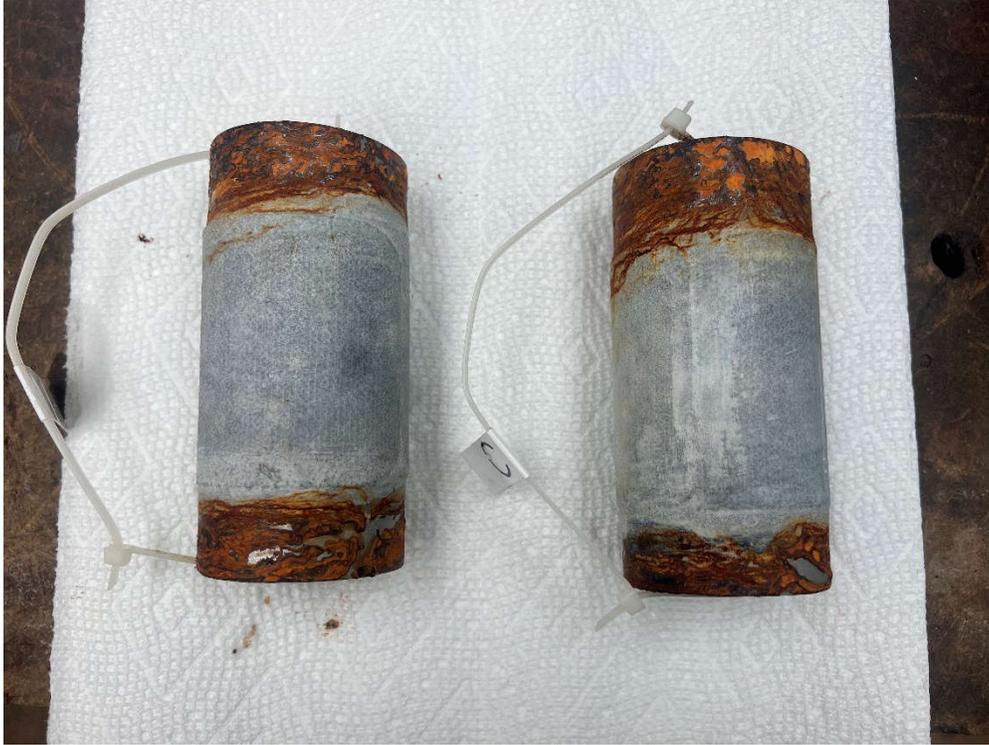
Figure 9: Photographs showing samples C after 100 hours of exposure.

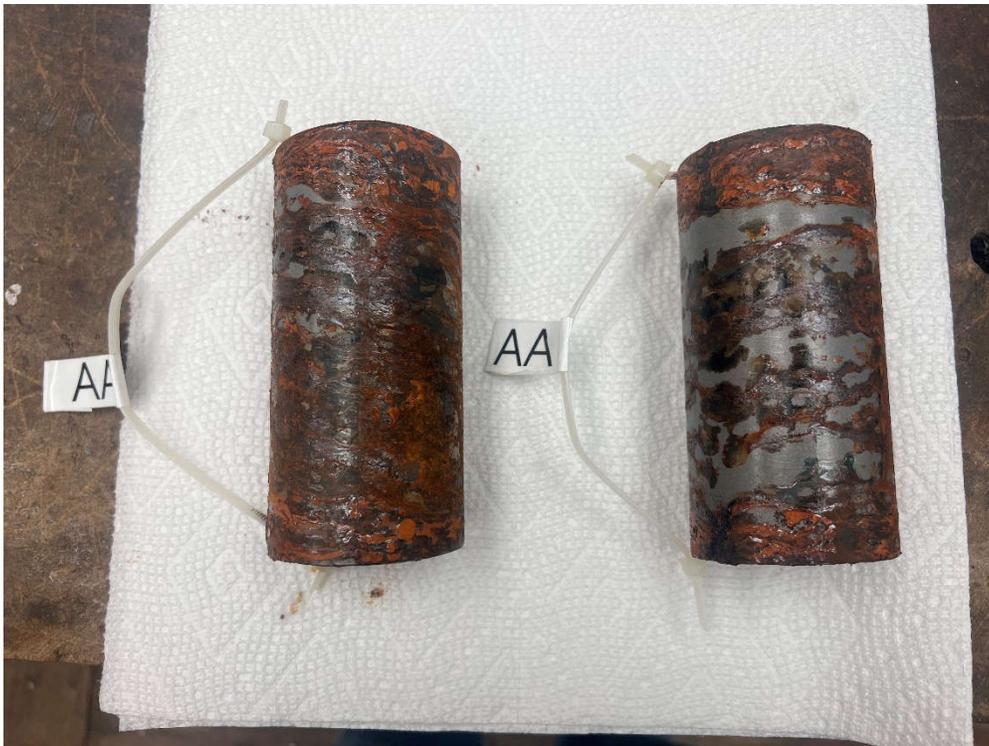
Figure 10: Photographs showing samples AA after 100 hours of exposure.

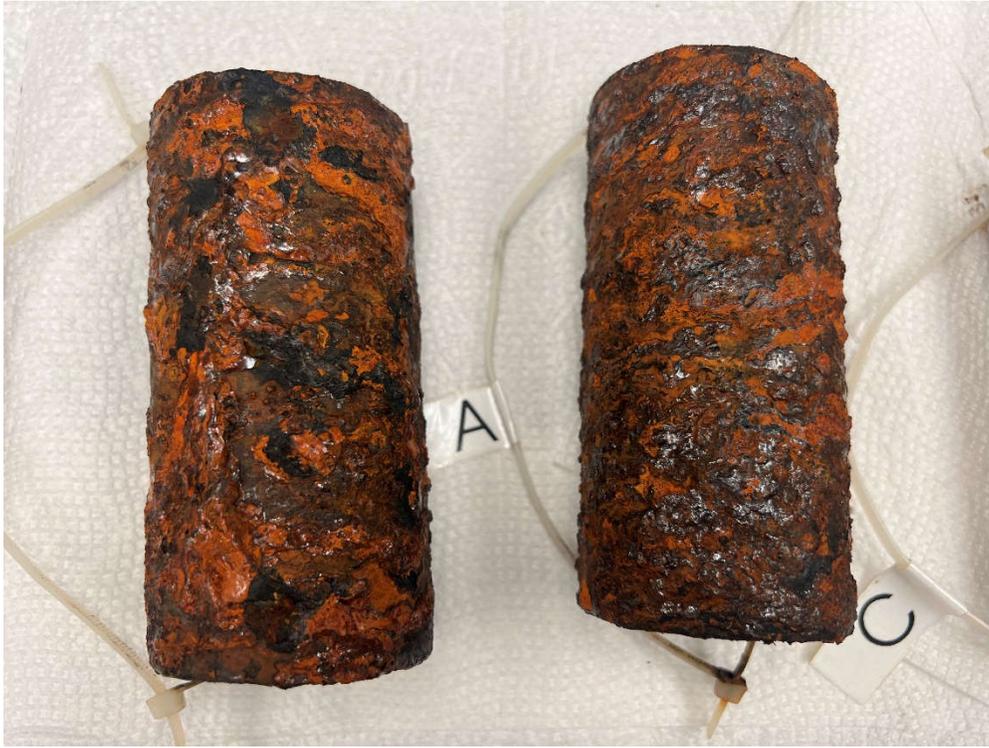
Figure 61: Photographs showing samples A after 1000 hours of exposure.

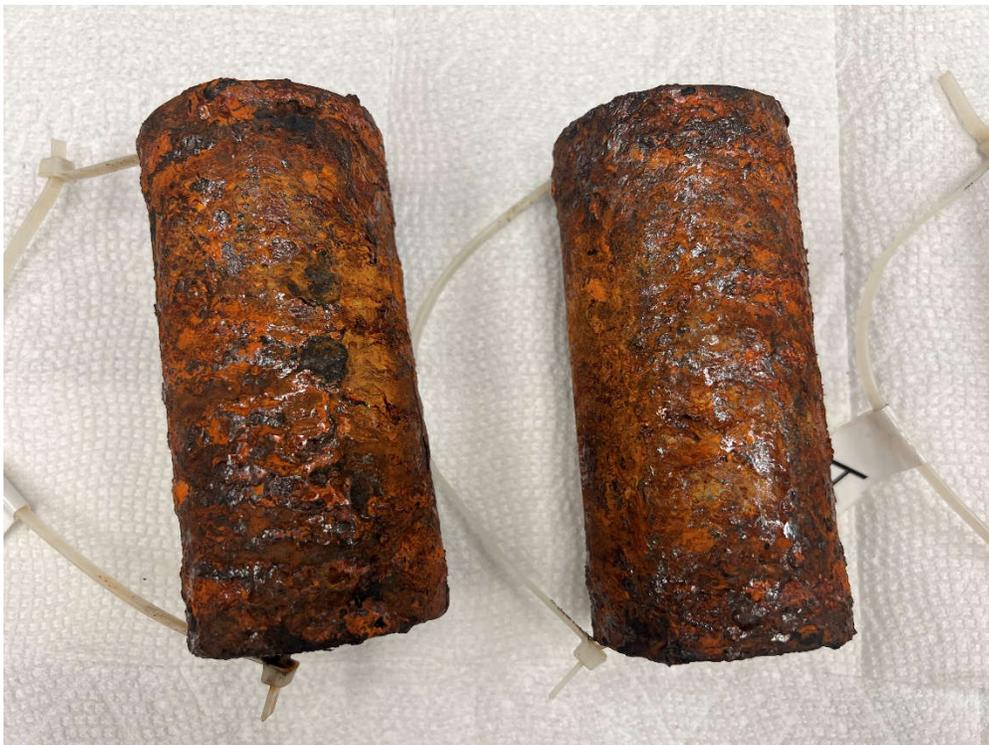
Figure 62: Photographs showing samples B after 1000 hours of exposure.

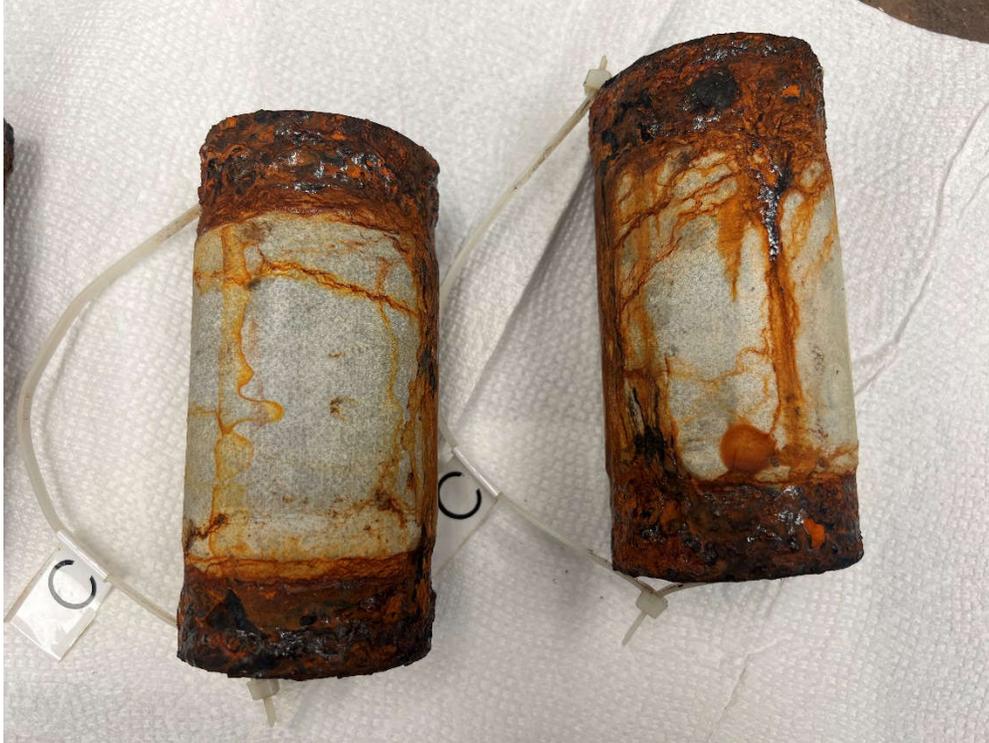
Figure 63: Photographs showing samples C after 1000 hours of exposure.

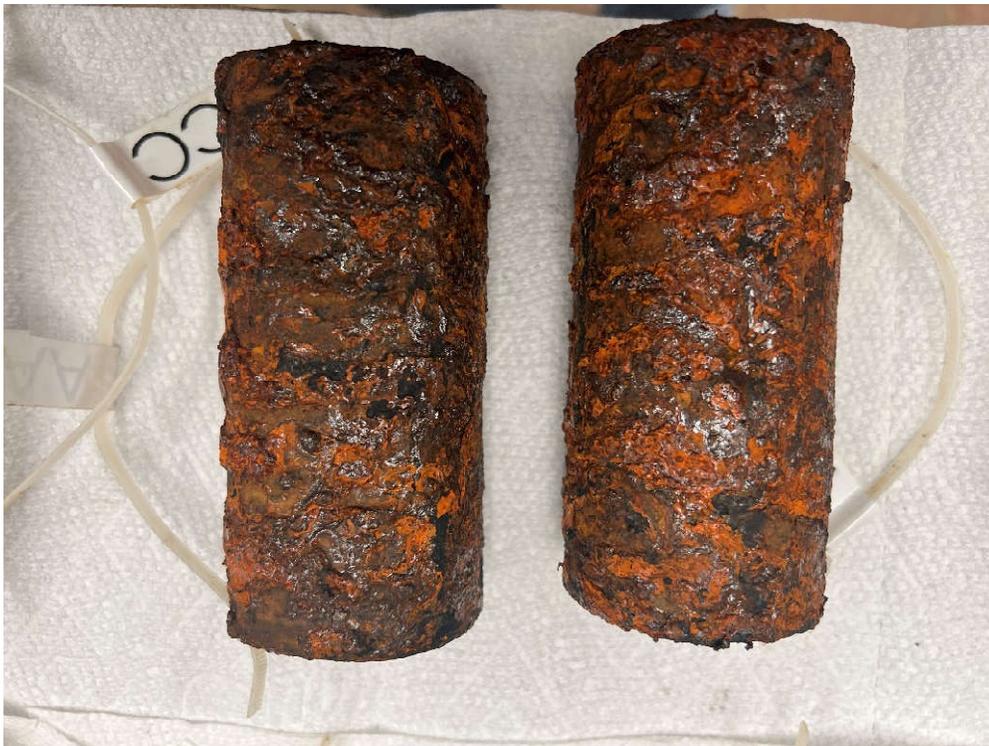
Figure 64: Photographs showing samples AA after 1000 hours of exposure.

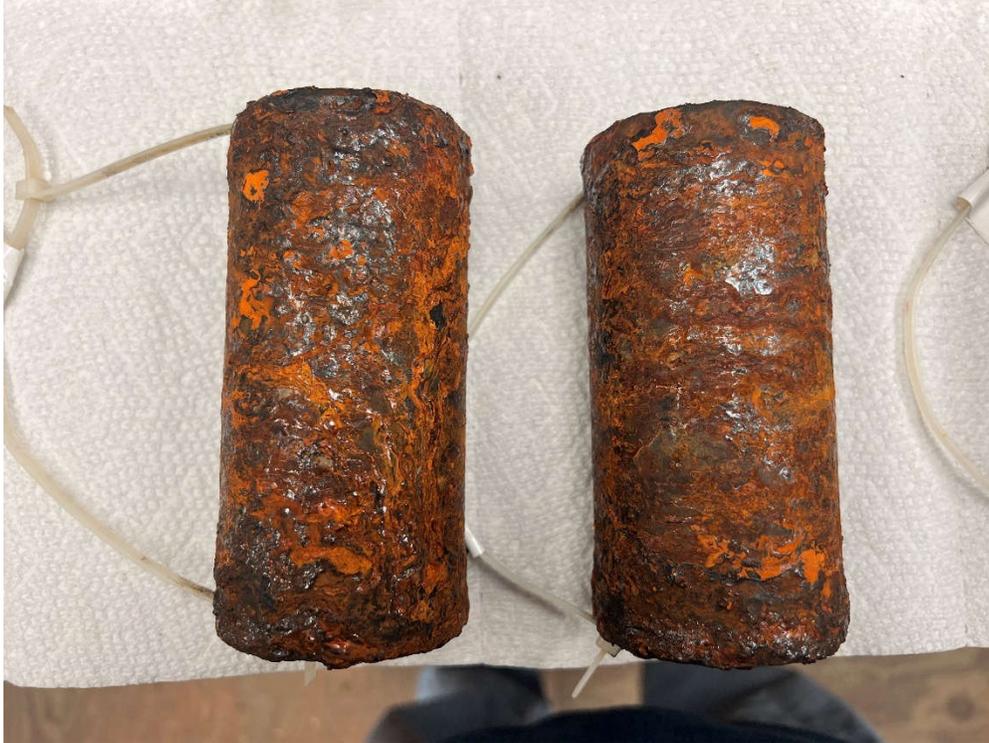
Figure 65: Photographs showing samples BB after 1000 hours of exposure.

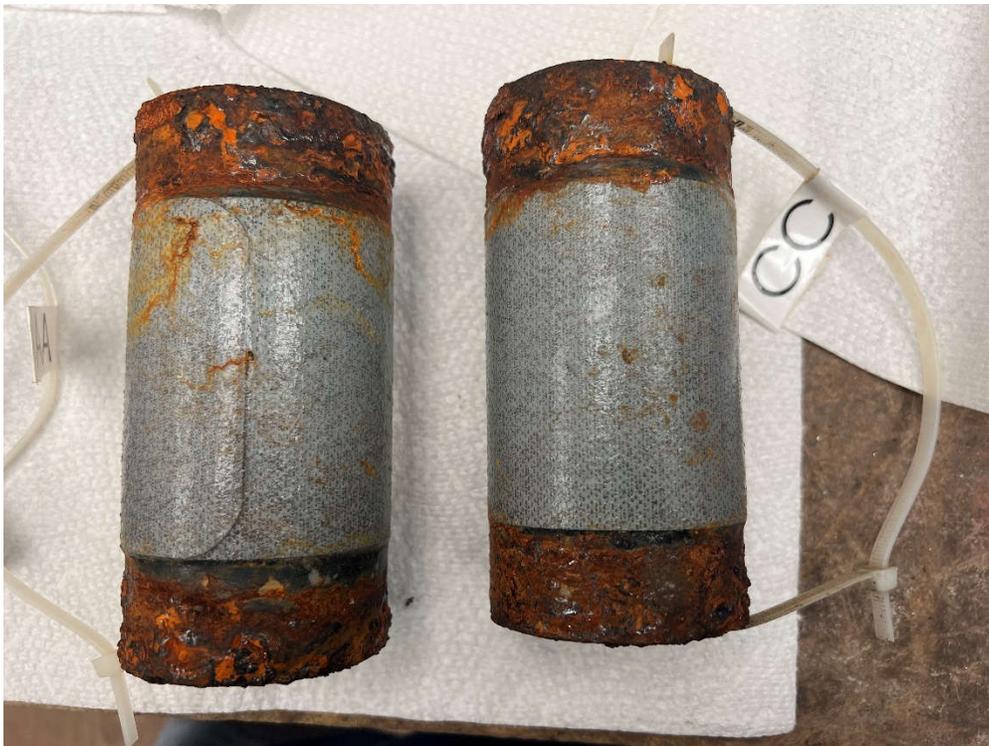
Figure 66: Photographs showing samples CC after 1000 hours of exposure.
