January 16, 2025

Donald Myers
Tech-Bond
381 South 30th Street
Heath, OH 43056

Test Report on: Salt Spray Testing of 12 steel tubes with various coatings.
MEi Test Report J0687.1, Issue 1

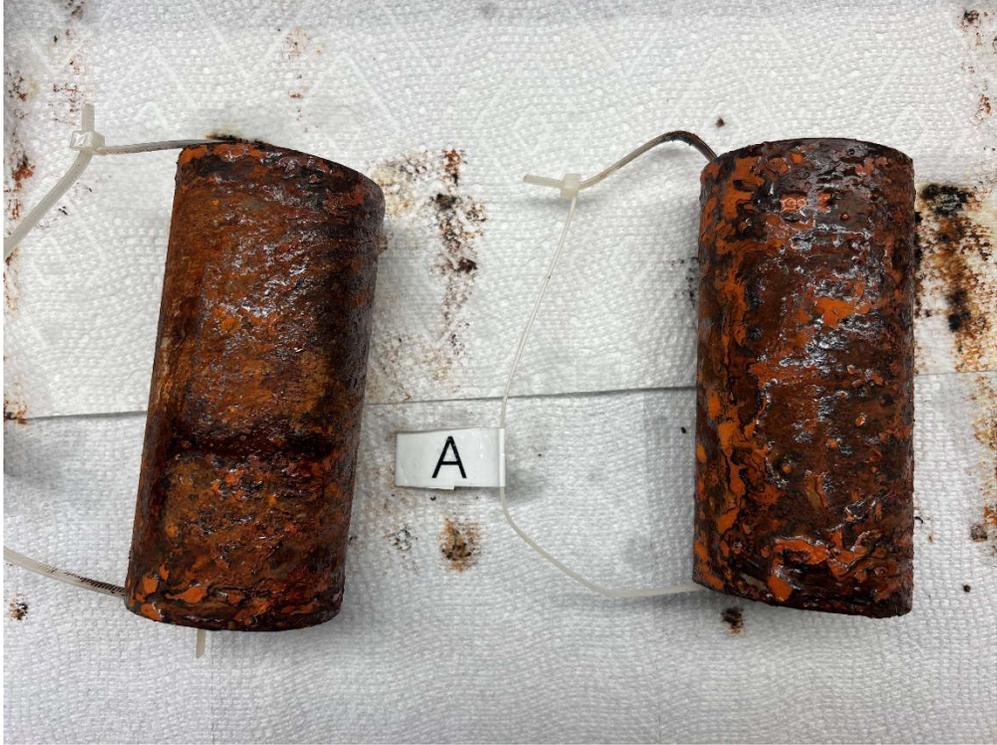
Figure 13: Photographs showing samples A after 200 hours of exposure.

Sample ID	100 Hours (Figure 7)	200 Hours (Figure 13)	300 Hours (Figure 19)	400 Hours (Figure 25)	500 Hours (Figure 31)
Samples A	Corrosion observed, majority of coated regions	Severe corrosion 100% coverage			
	600 Hours (Figure 37)	700 Hours (Figure 43)	800 Hours (Figure 49)	900 Hours (Figures 55)	1000 Hours (Figures 61)
	Severe corrosion 100% coverage	Severe corrosion 100% coverage	Severe corrosion 100% coverage	Severe corrosion 100% coverage	Severe corrosion 100% coverage
Sample ID	100 Hours (Figure 8)	200 Hours (Figure 14)	300 Hours (Figure 20)	400 Hours (Figure 26)	500 Hours (Figure 32)
Samples B	Corrosion observed, sparse coverage in coated regions	Corrosion observed, majority of coated regions	Corrosion observed, majority of coated regions	Corrosion observed, 100% coverage of coated regions/not severe	Severe corrosion 100% coverage
	600 Hours (Figure 38)	700 Hours (Figure 44)	800 Hours (Figures 50)	900 Hours (Figures 56)	1000 Hours (Figures 62)

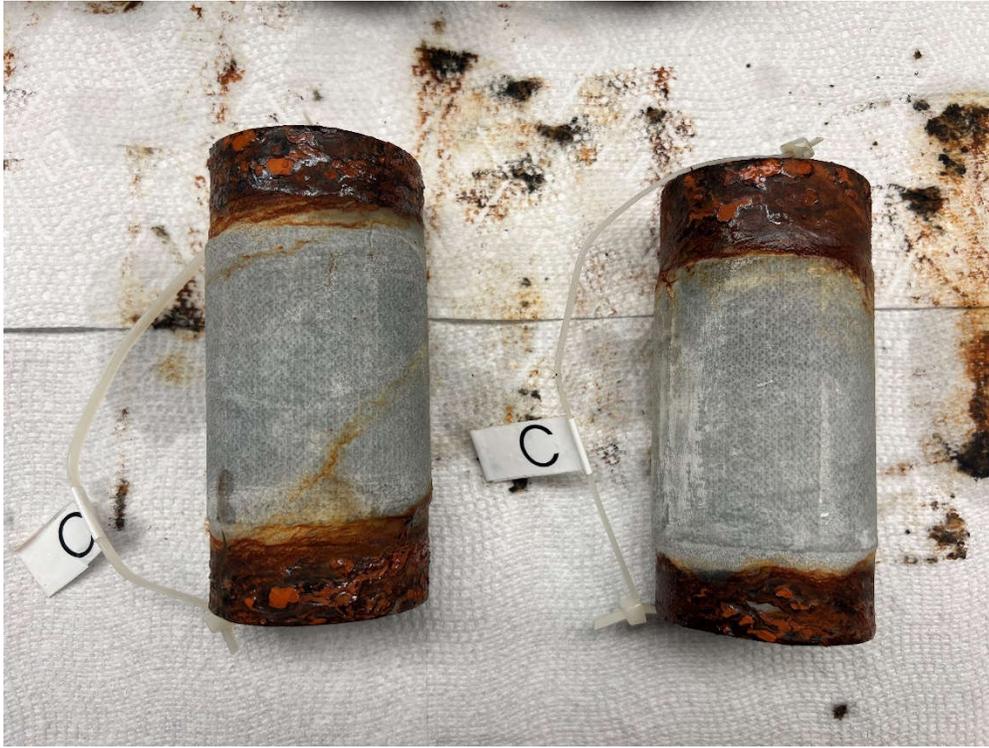
Figure 15: Photographs showing samples C after 200 hours of exposure.

Severe corrosion 100% coverage	Severe corrosion 100% coverage	Severe corrosion 100% coverage	Severe corrosion 100% coverage	Severe corrosion 100% coverage
Sample ID	100 Hours (Figure 9)	200 Hours (Figure 15)	300 Hours (Figure 21)	400 Hours (Figure 27)	500 Hours (Figure 33)
Samples C	Corrosion observed, little to no coverage in coated regions	Corrosion observed, some discoloration at edges of coated regions	Corrosion observed, some discoloration at edges of coated regions	Corrosion observed, some discoloration at edges of coated regions	Corrosion observed, some discoloration at edges of coated regions
	600 Hours (Figure 39)	700 Hours (Figure 45)	800 Hours (Figure 51)	900 Hours (Figure 57)	1000 Hours (Figure 63)
	Corrosion observed, some attack at edges of coated regions	Corrosion observed, some attack at edges of coated regions	Corrosion observed, more severe attack at edges of coated regions	Corrosion observed, more severe attack at edges of coated regions	Corrosion observed, some attack in main coating region

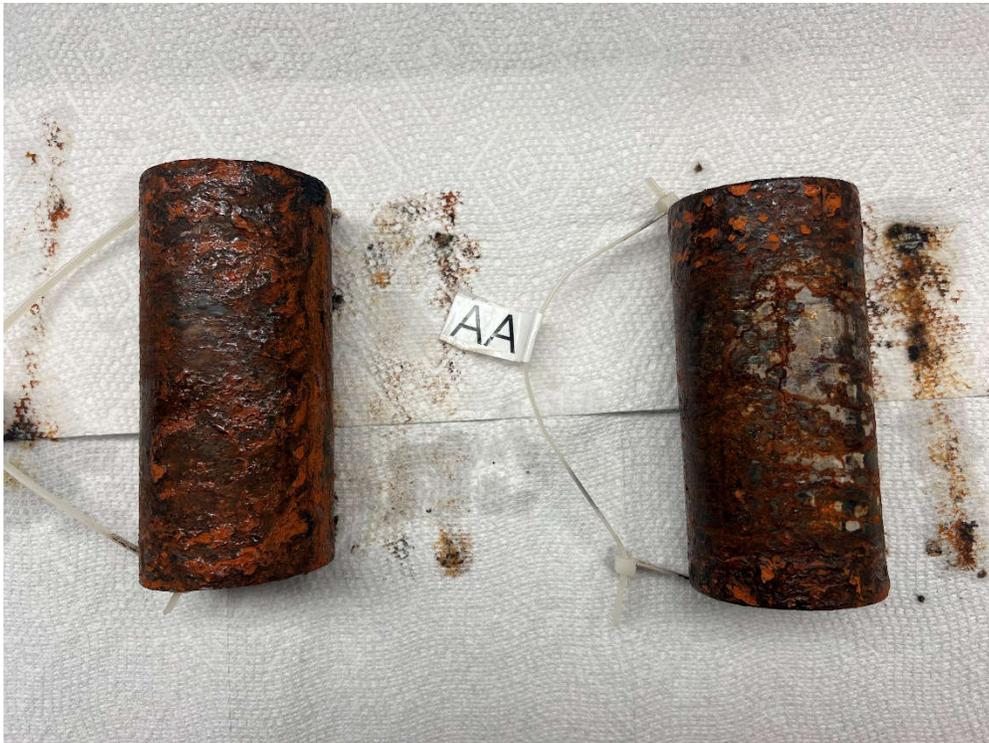
Figure 16: Photographs showing samples AA after 200 hours of exposure.

Sample ID	100 Hours (Figure 10)	200 Hours (Figure 16)	300 Hours (Figure 22)	400 Hours (Figure 28)	500 Hours (Figure 34)
Samples AA	Corrosion observed, majority of coated regions	Corrosion observed, majority of coated regions	Severe corrosion 100% coverage	Severe corrosion 100% coverage	Severe corrosion 100% coverage
	600 Hours (Figure 40)	700 Hours (Figure 46)	800 Hours (Figure 52)	900 Hours (Figure 58)	1000 Hours (Figure 64)
	Severe corrosion 100% coverage	Severe corrosion 100% coverage	Severe corrosion 100% coverage	Severe corrosion 100% coverage	Severe corrosion 100% coverage
Sample ID	100 Hours (Figure 11)	200 Hours (Figure 17)	300 Hours (Figure 23)	400 Hours (Figure 29)	500 Hours (Figure 35)
Samples BB	Corrosion observed, moderate coverage in coated regions	Corrosion observed, majority of coated regions	Corrosion observed, majority of coated regions	Corrosion observed, majority of coated regions	Corrosion observed, majority of coated regions

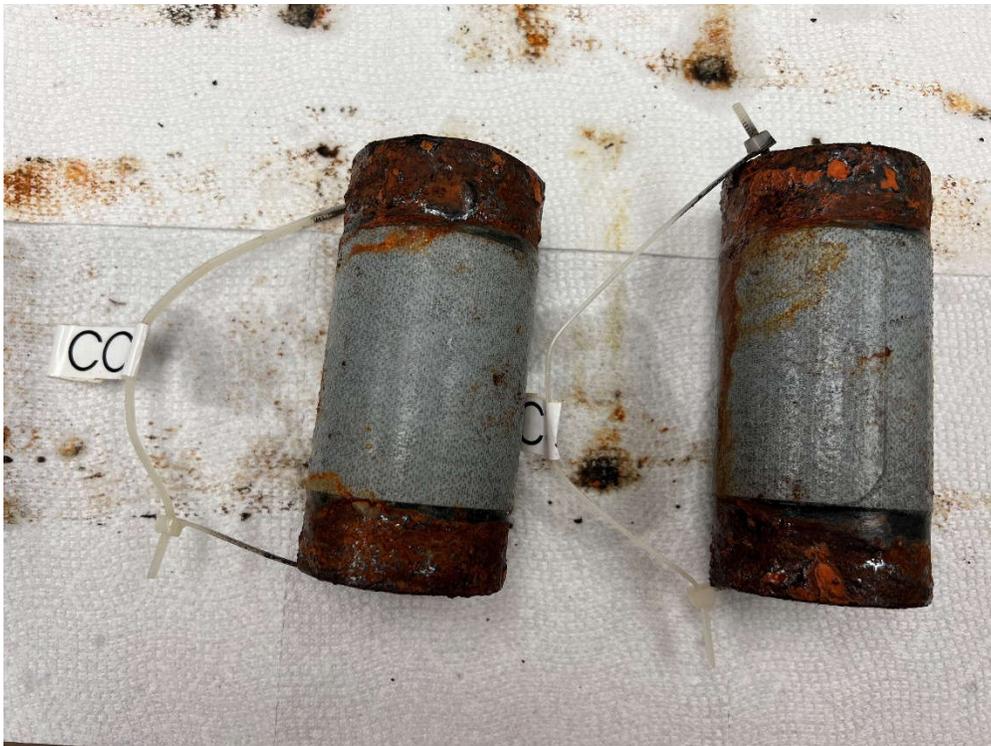
Figure 42: Photographs showing samples CC after 600 hours of exposure.

600 Hours (Figures 41)	700 Hours (Figures 47)	800 Hours (Figures 53)	900 Hours (Figures 59)	1000 Hours (Figures 65)
	Corrosion observed, majority of coated regions	Corrosion observed, majority of coated regions	Severe Corrosion	Severe Corrosion 100% coverage	Severe Corrosion 100% coverage
Sample ID	100 Hours (Figure 12)	200 Hours (Figure 18)	300 Hours (Figure 24)	400 Hours (Figure 30)	500 Hours (Figure 36)
Samples CC	Corrosion observed, no coverage in coated regions	Corrosion observed, no coverage in coated regions (some discoloration from runoff)	Corrosion observed, no coverage in coated regions (some discoloration from runoff)	Corrosion observed, no coverage in coated regions (some discoloration from runoff)	Corrosion observed, no coverage in coated regions (some discoloration from runoff)
	600 Hours (Figure 42)	700 Hours (Figure 48)	800 Hours (Figure 54)	900 Hours (Figure 60)	1000 Hours (Figure 66)

Corrosion observed, edges of coated regions blackened	Corrosion observed, edges of coated regions blackened	Corrosion observed, edges of coated regions blackened	Corrosion observed, edges of coated regions blackened	Corrosion observed, edges of coated regions blackened
